Manhole Inspection Summary

Manhole # S47C__003MH

Insp Date: 7/11/08 1:28 PM

Location Address: **Paterson Park**

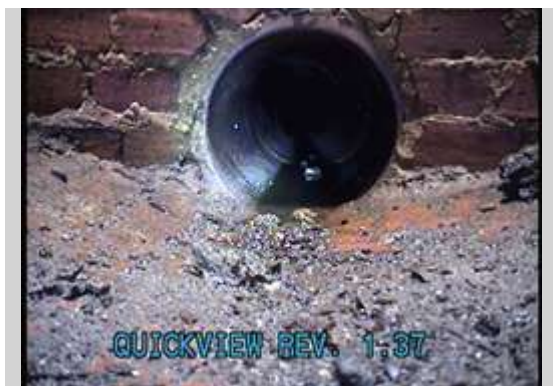
12 O'Clock Outflow

8 in. Circular Gravity Sewer
Pipe Out @ 12 O'Clock

Infiltration: **None** Pipe Seal Cond: **Sound**
